H14/14

DATE: 29 MAY 14

POTENTIAL SAFETY ISSUE WHEN ABOVE NORMAL GLIDEPATH ON ILS APPROACHES

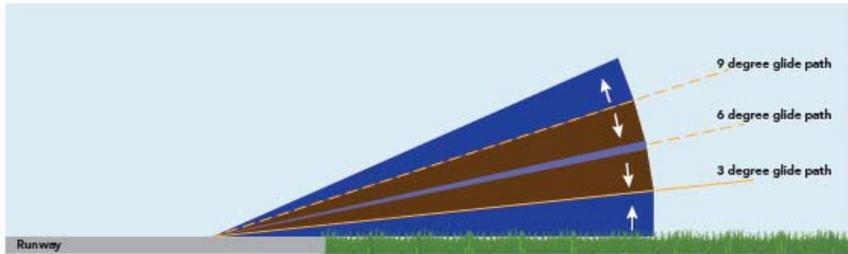
4.2 Analysis of the measurements shows that between the 3 and 9 degree glide path, signal strength changes. For the pilot this can result in observable movement of the ILS glide slope marker on the primary flight display. At this time two important characteristics of the M-array ILS antenna 'glide slope field' have been identified:

- a. A signal reversal was always present at approximately 9 degree glide path.
 - b. A signal reversal was sometimes present at approximately 6 degree glide path.
-

Figure 1: Cross section view of the M-array ILS antenna system. Schematic overview of the “Fly up”(blue) and “Fly down”(brown) indication.

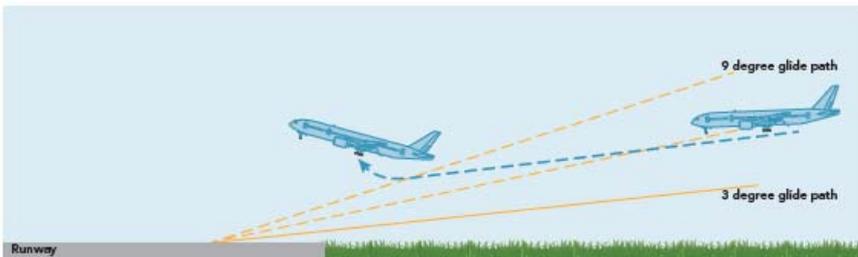
Figure 2: Example of glide slope capture with a pitch upset above 3 degree glide path.

4.3 Depending on the glide slope field, signal reversal occurs occasionally at 6 degree, and always at the 9 degree glide path. This reversal activates the glide slope capture mode after which the autopilot follows the glide slope signal without restrictions. During flight tests the reversal resulted in the automatic flight control system commanding a severe pitch-up. Immediate flight crew intervention was required to regain aircraft control.

5.1 Pilots should be vigilant for potential false glide slope signals when intercepting any ILS glide slope from above, and aware of the potential issues associated with flying in the area above the 3 degree glide path during the approach. This is particularly important while flying on autopilot with the glide slope mode armed.

6.1 Operators should consider the need to implement additional operational procedures or provide additional guidance in order to mitigate the risks of unexpected autopilot behaviour when on ILS approaches.

7.1 Whenever possible, ATC should issue control instructions that will position the aircraft to intercept the glide slope from below.
