STANDARD INSTRUMENT DEPARTURES (SID) ROCKHAMPTON THREE DEPARTURE (RADAR) RWY 15 & 33

ROCKHAMPTON THREE DEPARTURE (RADAR)

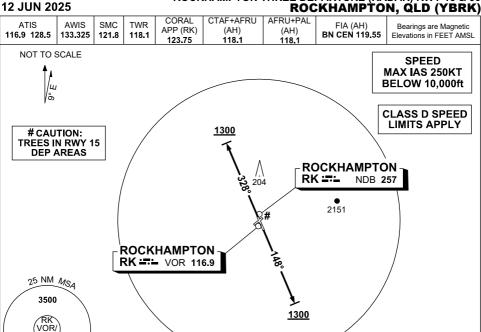
BRKDP01-183

RWY 15

- GRAD 3.3%
- Track 148°

10 NM MSA 3200

AT 1300ft turn to assigned heading or track

RWY 33

- GRAD 3.4% to 2500ft, then 3.3%
- Track 328°
- AT 1300ft turn to assigned heading or track

- Squawk 7600
- Maintain last assigned vector for two minutes, and
- CLIMB IF NECESSARY TO MINIMUM SAFE ALTITUDE, to maintain terrain clearance, then
- proceed in accordance with the latest ATC route clearance acknowledged.
