Airservices Australia

Sunshine Coast Airport

Preliminary Site Investigation

March 2019

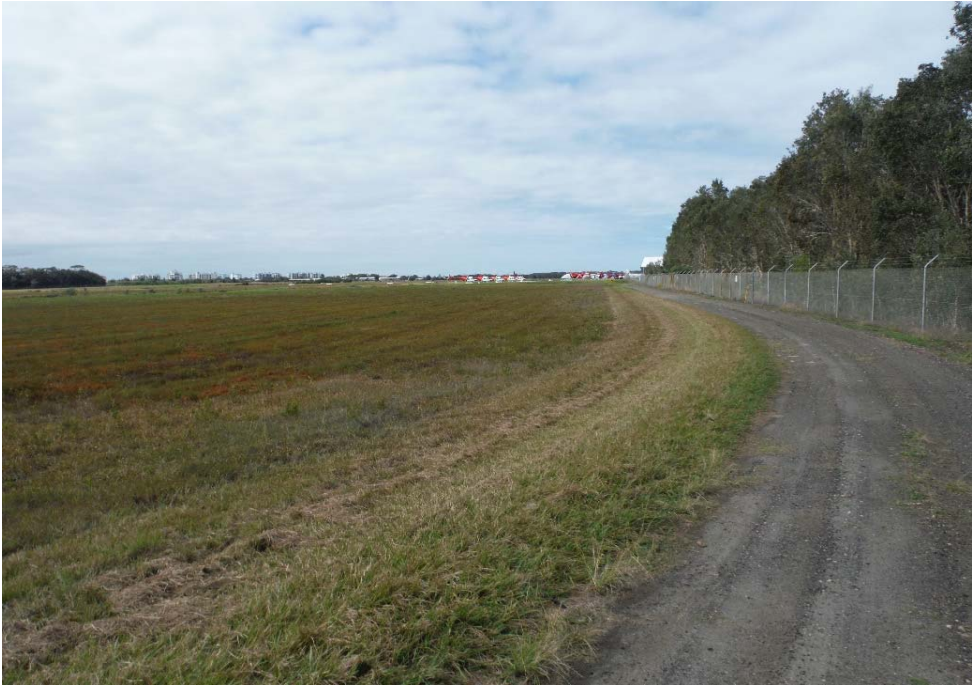
Photograph 5	Photo
<p>View facing north east into the airport from Gate 16 where performance testing took place into the grassy areas</p>

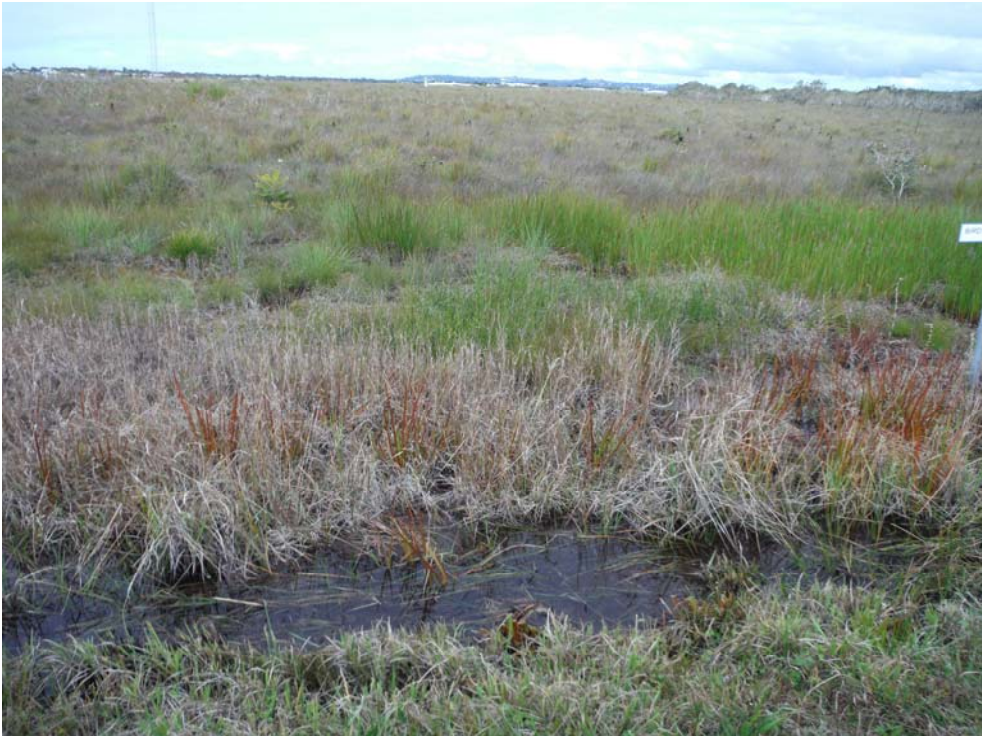
Photograph 6	Photo
<p>View facing east from north of the runway (from the boundary road). Groundwater can be seen daylighting. This is apparent throughout the site, in most of the grassed areas</p>

Groundwater 'daylights' (rises above the surface) at most vegetated areas of the site and these areas present as marshy wetlands. Groundwater is observed through most times of the year, not just at times of high rainfall.

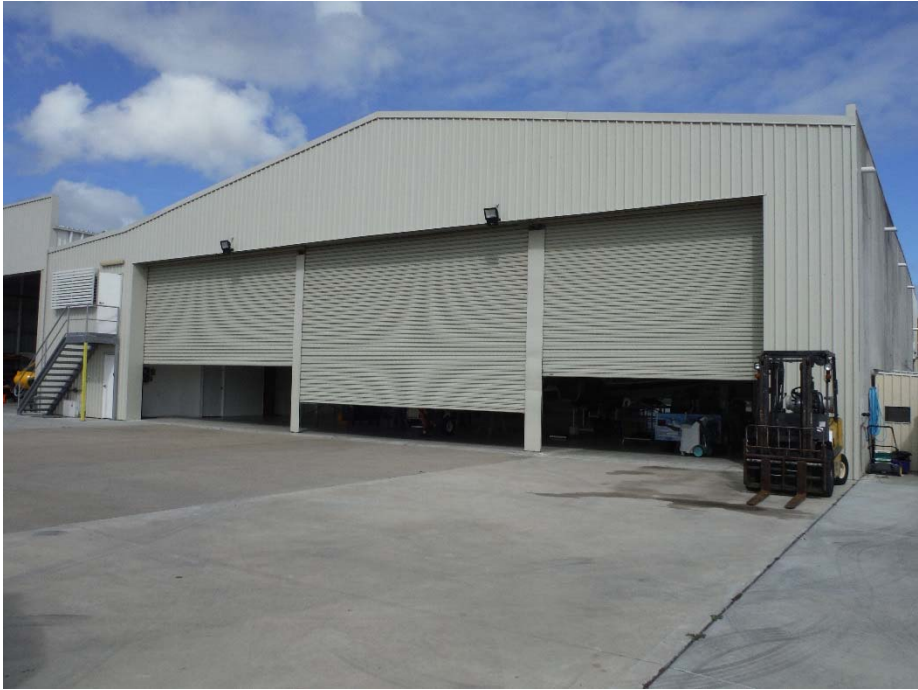
Photograph 7	Photo
<p>Former fire station (FSS). The hanger has been extended and additional grassed areas sealed since use as a fire station. The (newly sealed) concrete on the right of the photo (near the forklift)</p>

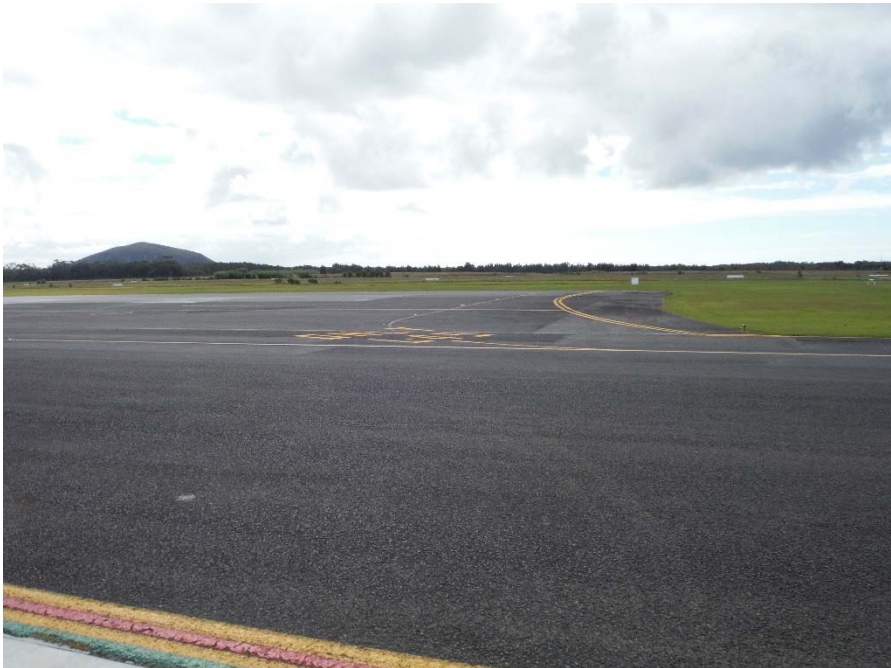
Photograph 8	Photo
<p>Taxiway to the north of the FFS.</p>
