**STANDARD INSTRUMENT DEPARTURES (SID)
AMBERLEY ONE DEPARTURE (RADAR) - RWY 15/33
AMBERLEY, QLD (YAMB)**

1 MAR 2018

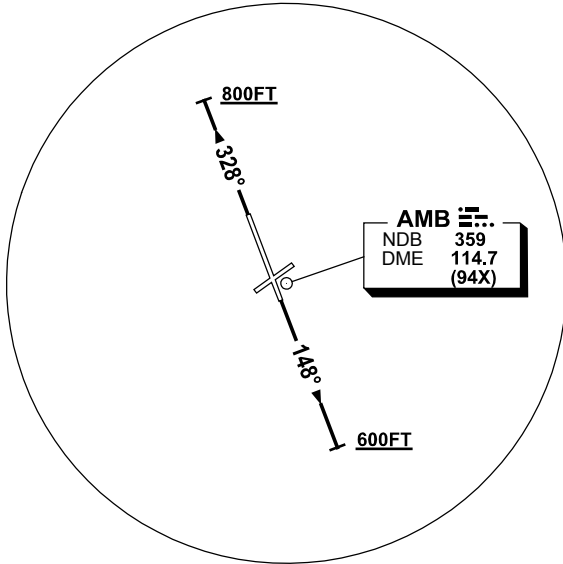
AMBERLEY ONE DEPARTURE

RWY 15

- GRAD 4.3% to 2700FT, then 3.3%
- Track 148°
- At 600FT BUT NOT BEFORE DER, turn to assigned heading (NO LEFT TURN BLW 1600FT)

RWY 33

- GRAD 3.9% to 800FT, then 3.3%
- Track 328°
- At or ABV 800FT BUT NOT BEFORE 4 DME, turn to assigned heading
