STANDARD INSTRUMENT DEPARTURES (SID) ESSENDON EIGHT DEPARTURE (RADAR) **MELBOURNE/ESSENDON, VIC (YMEN)**

21 MAY 2020

ESSENDON EIGHT DEPARTURE (RADAR)

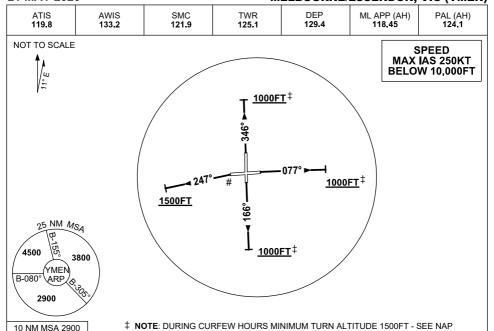
RWY 08

- GRAD 3.3%
- Track 077°
 At 1000FT[‡] BUT NOT BEFORE DER turn to assigned heading or track

RWY 26

- GRAD 3.3%
- Track 247°
- At 1500FT BUT NOT BEFORE DER turn to assigned heading

RWY 17

- GRAD 3.6% to 1600FT then 3.3%
- Track 166°
- At 1000FT[‡] BUT NOT BEFORE DER turn to assigned heading or track

RWY 35

- GRAD 3.3%
- Track 346°
- At 1000FT [‡] BUT NOT BEFORE DER turn to assigned heading or track
