# STANDARD INSTRUMENT DEPARTURES (SID) ROCKHAMPTON THREE DEPARTURE (RADAR) RWY 15 & 33 ROCKHAMPTON, QLD (YBRK)

# 1 DEC 2022

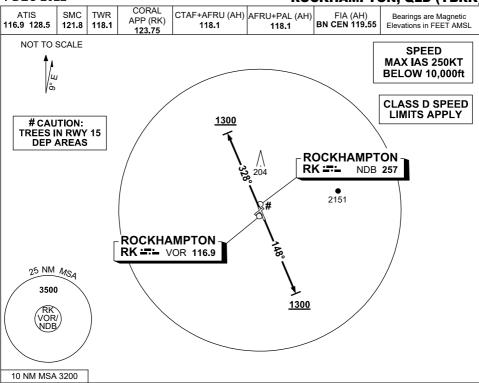
# ROCKHAMPTON THREE DEPARTURE (RADAR)

# **RWY 15**

- GRAD 3.3%
- Track 148°
- AT 1300ft turn to assigned heading or track

#### **RWY 33**

- GRAD 3.4% to 2500ft, then 3.3%
- Track 328°
- AT 1300ft turn to assigned heading or track

# COMMUNICATIONS FAILURE PROCEDURE

On recognition of communications failure

- Squawk 7600
- Maintain last assigned vector for two minutes, and
- CLIMB IF NECESSARY TO MINIMUM SAFE ALTITUDE, to maintain terrain clearance, then
- proceed in accordance with the latest ATC route clearance acknowledged.
