STANDARD INSTRUMENT DEPARTURES (SID) ROCKHAMPTON THREE DEPARTURE (RADAR) RWY 15 & 33

12 JUN 2025

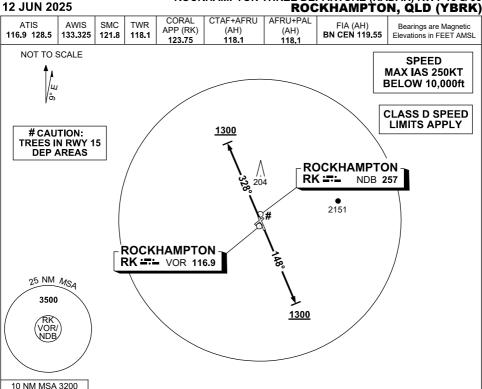
ROCKHAMPTON THREE DEPARTURE (RADAR)

RWY 15

- GRAD 3.3%
- Track 148°
- AT 1300ft turn to assigned heading or track

RWY 33

- GRAD 3.4% to 2500ft, then 3.3%
- Track 328°
- AT 1300ft turn to assigned heading or track
